## **Microplastic in Swiss Alpine Lentic** Waters: the Case of Cadagno Lake.

## Serera M. Abel, Patricia Burkhardt-Holm (Serena.abel@unibas.ch, patricia.holm@unibas.ch)

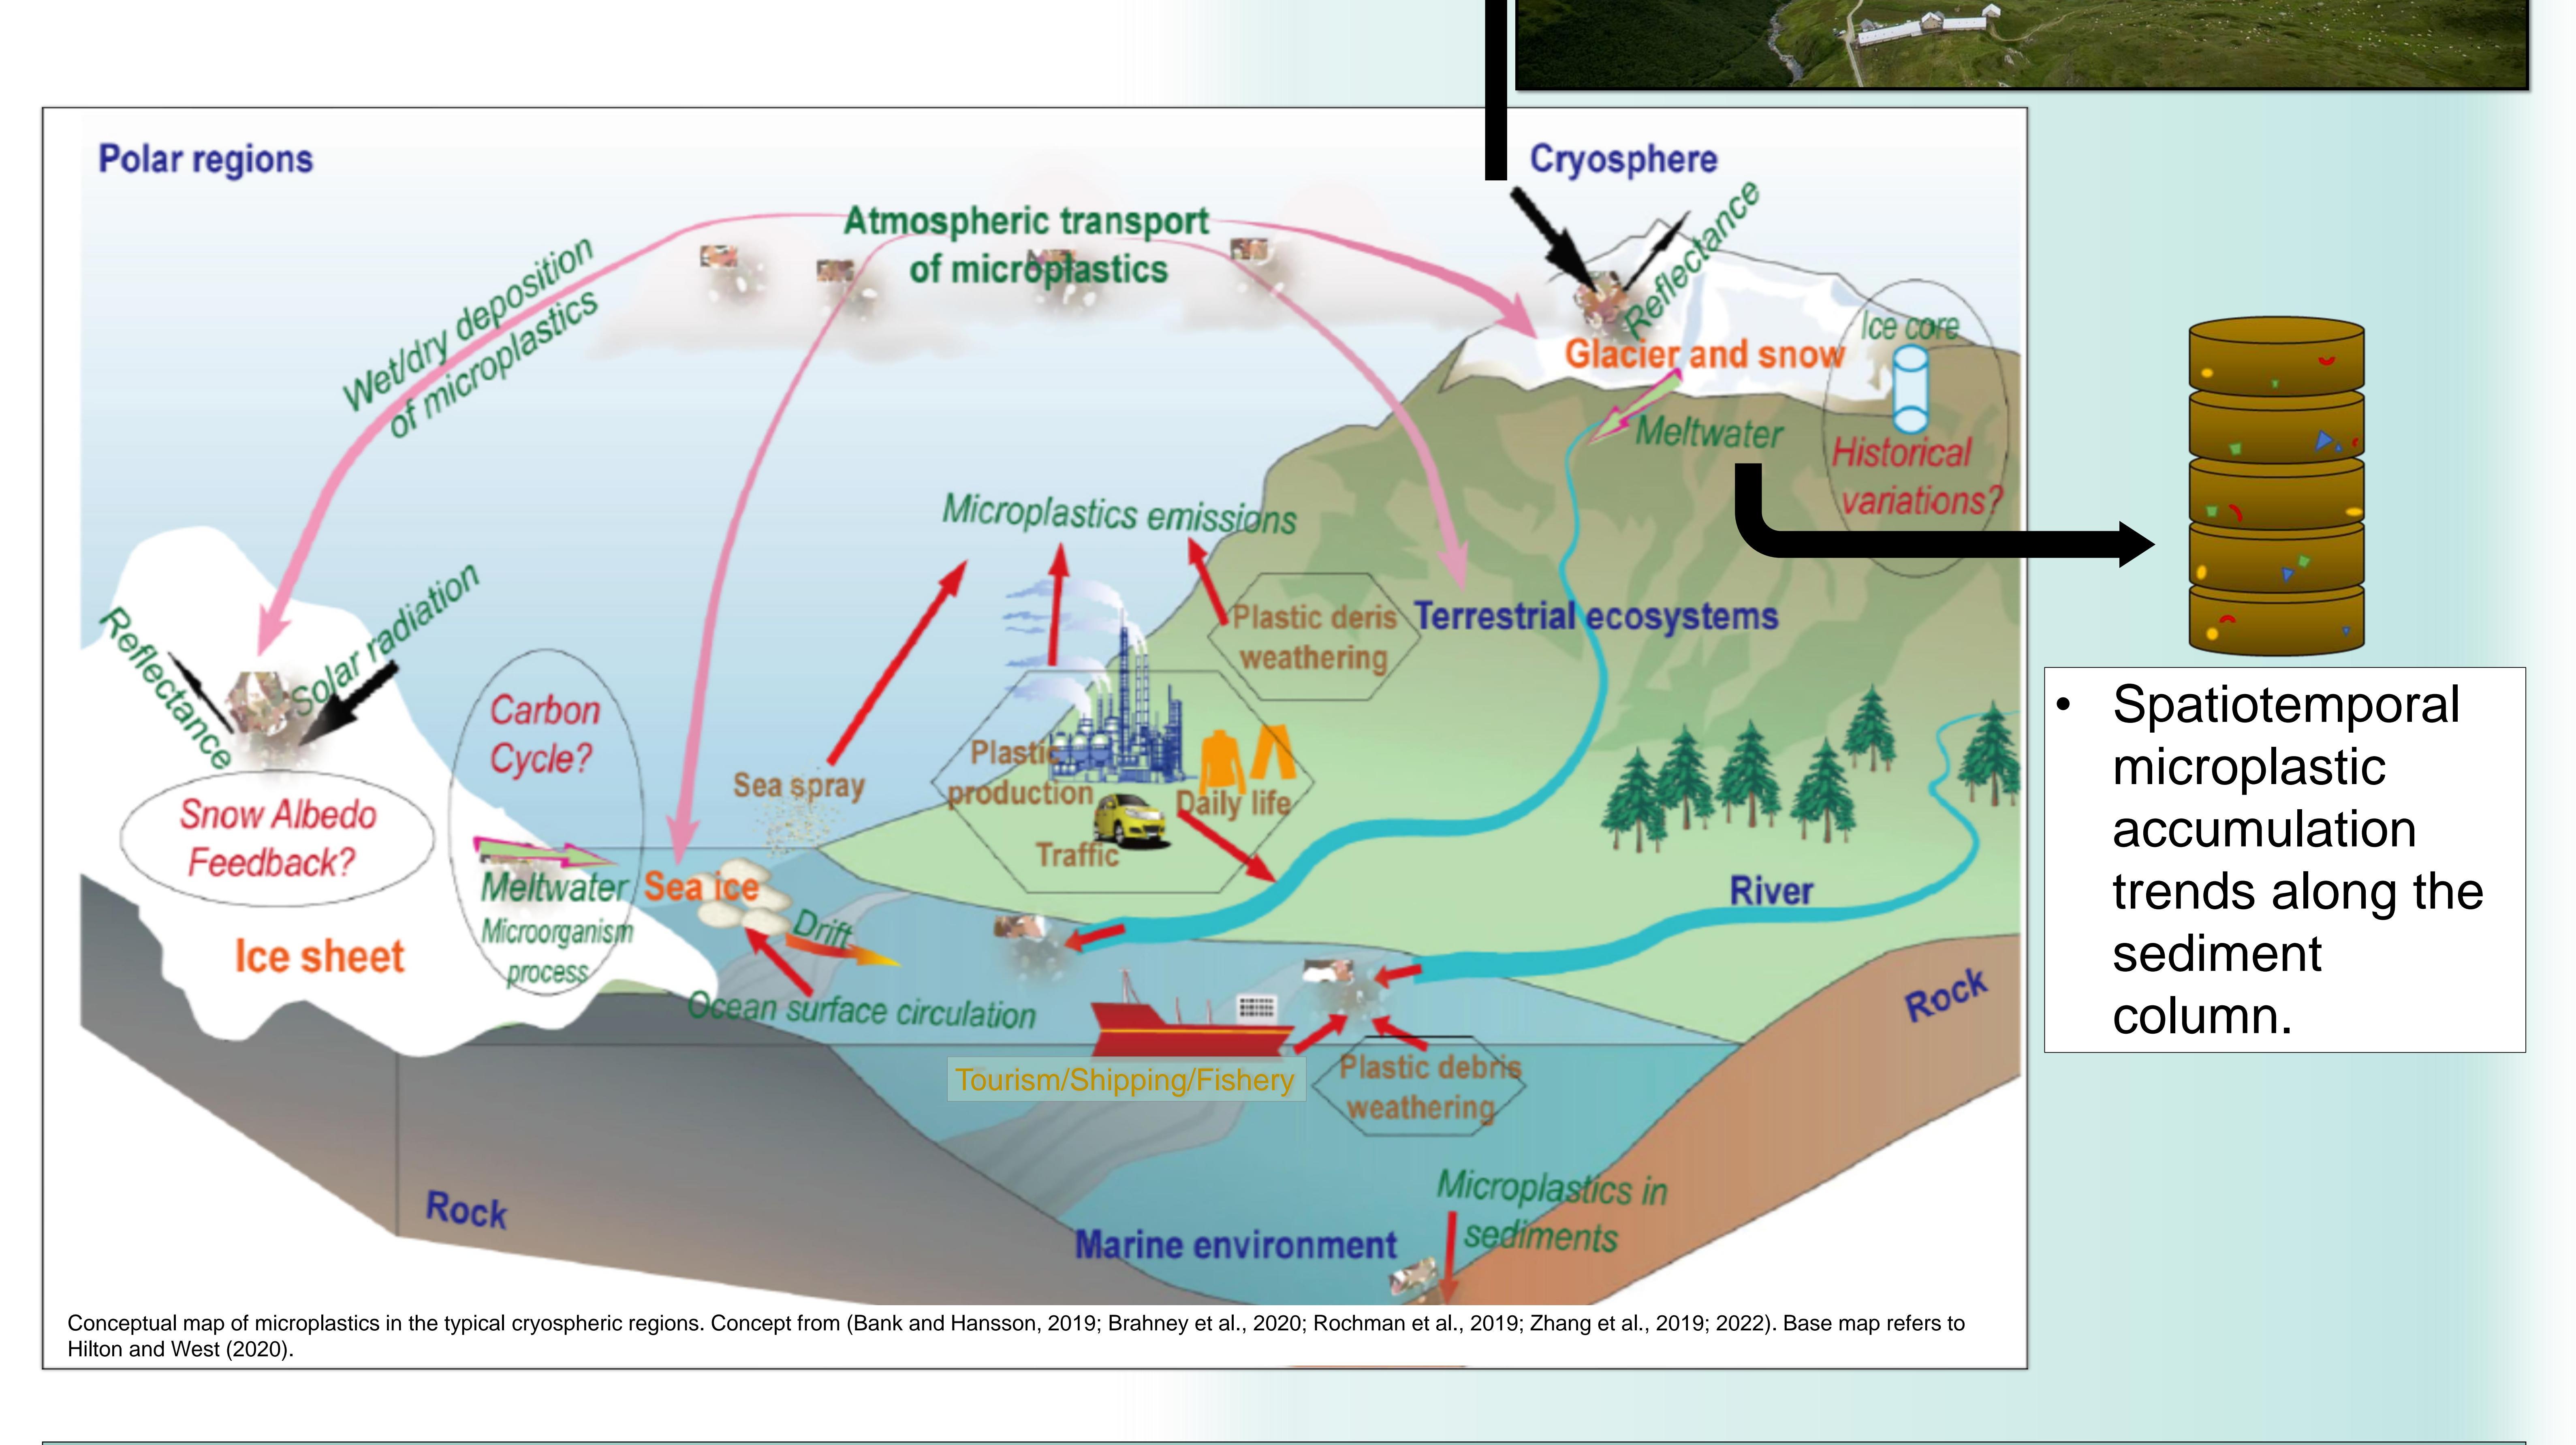
**Proof of concept:** presence of microplastic (> 500 µm) in the lake sediment. Cadagno lake shows plastic contamination. Outlook: draft the spatial-temporal deposition of MP in alpine lakes and have new insights about the potential effects the sediment nutritional value in sediments of oligotrophic waterbodies.
